NASA CR-72966
R-8494-2

ROTATING AND POSITIVE-DISPLACEMENT PUMPS
FOR
LOW-THRUST ROCKET ENGINES

FINAL REPORT
VOLUME II
FABRICATION AND TESTING

ROCKETDYNE DIVISION
ROCKWELL INTERNATIONAL
CANOGA PARK, CALIFORNIA

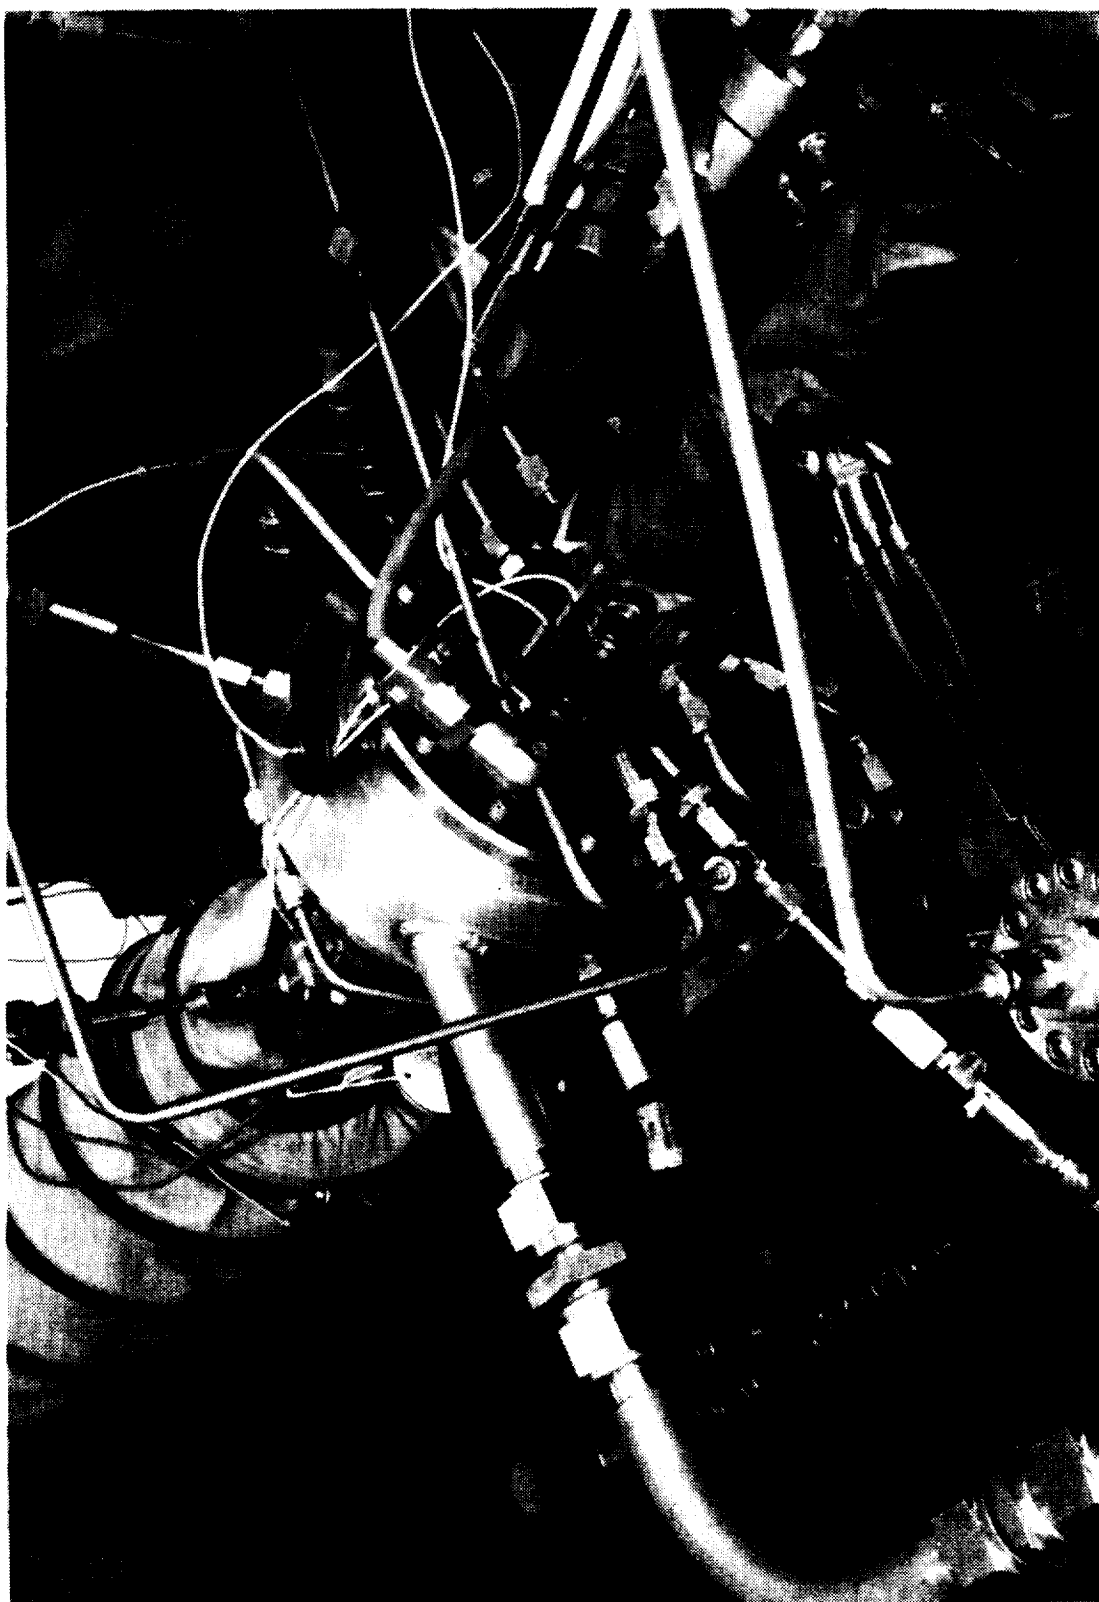
IXY56-6/22/70-C1C

Testing of the centrifugal pump with Freon-12 was accomplished in Rotary Test Cell #2 of Rocketdyne's Engineering Development Laboratory at Canoga Park, California. A schematic of the facility configuration is presented in Fig. 11. The pump installation in the test cell is shown in Fig. 12, 13 and 14.

Figure 14. Mark 36 Centrifugal Pump Installed for Testing With Freon 12

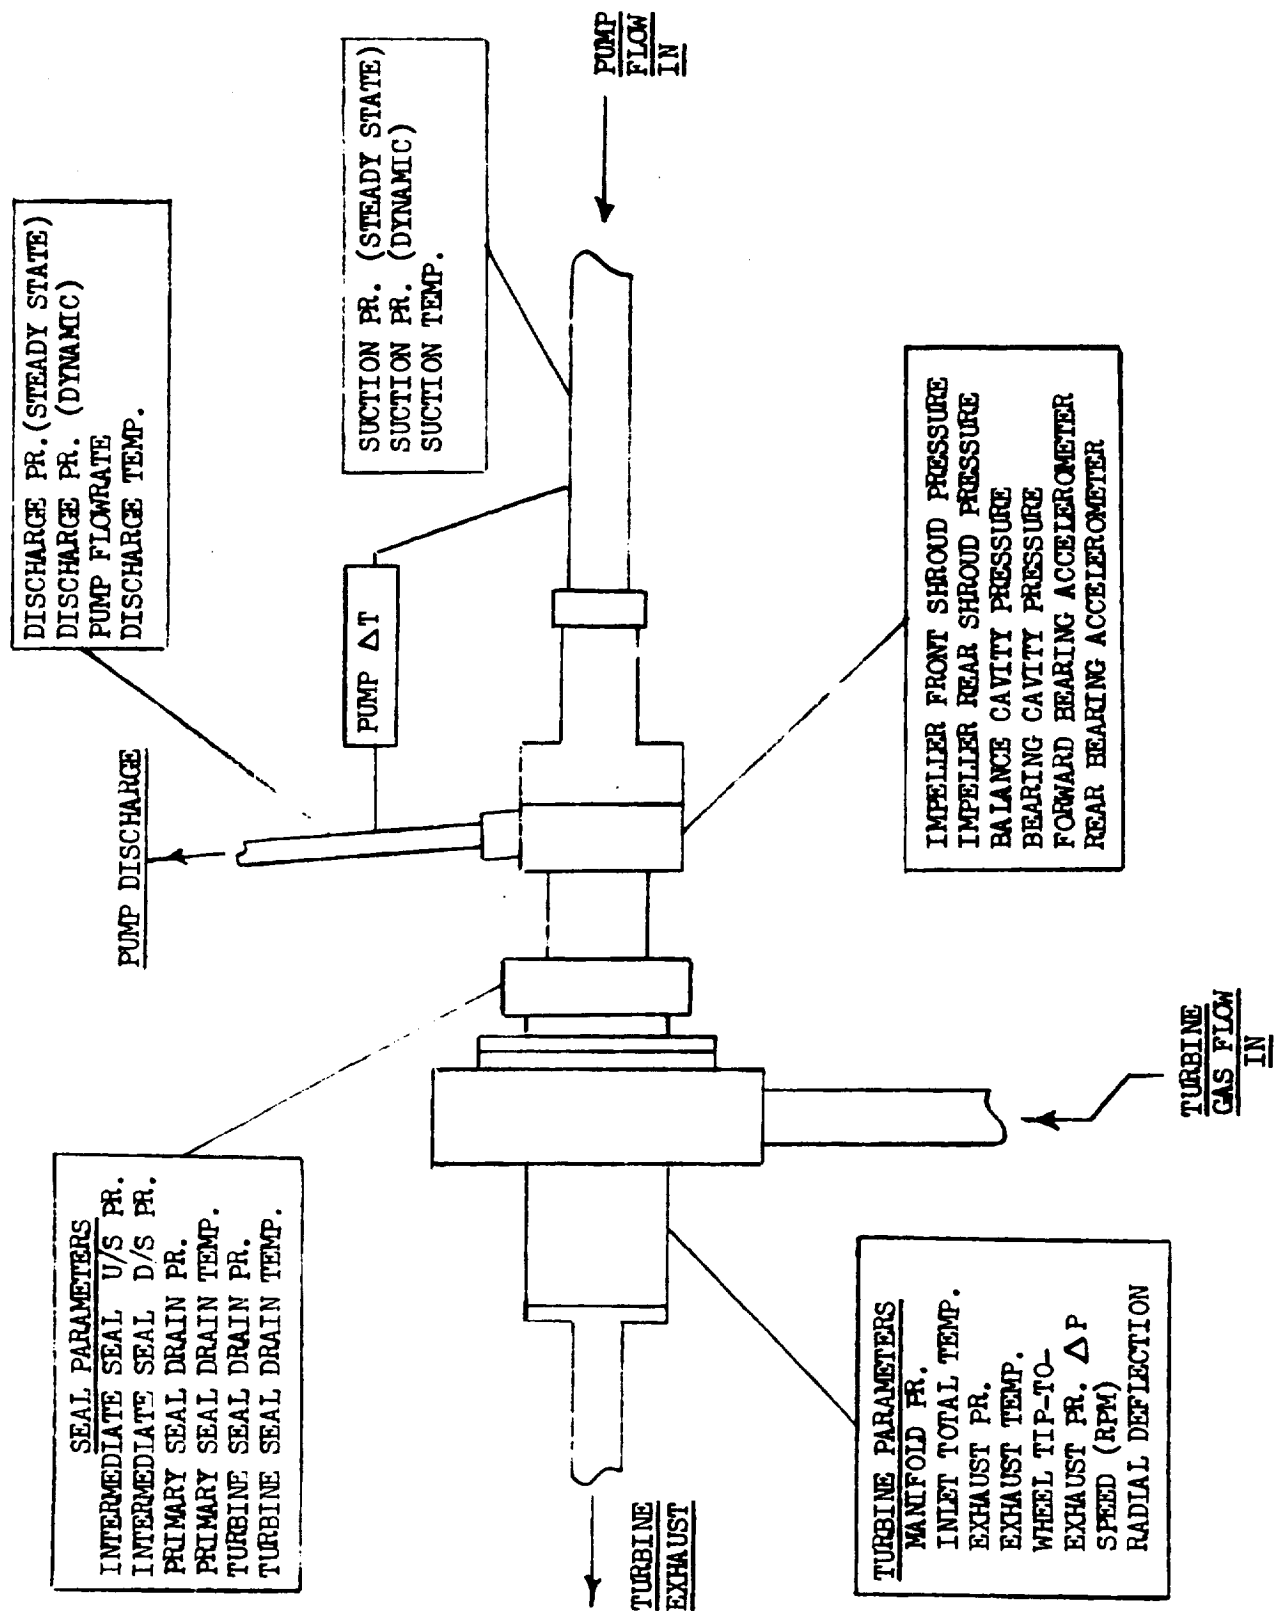
The radial motion of the shaft in the plane of the turbine disk was measured with a Bently inductive-type noncontacting displacement measuring device (Bently Nevada Corp., Minden, Nevada). In addition to recording the Bently output on tape, it was also displayed on an oscilloscope and continuously monitored during the tests. A Bently transducer was also used to obtain a shaft speed indication. This was accomplished by

Figure 15. Mark 36 (12 gpm) Centrifugal Pump Instrumentation

machining a spotface in the turbine disk opposite the Bently transducer, which then produced a countable electronic signal every revolution.

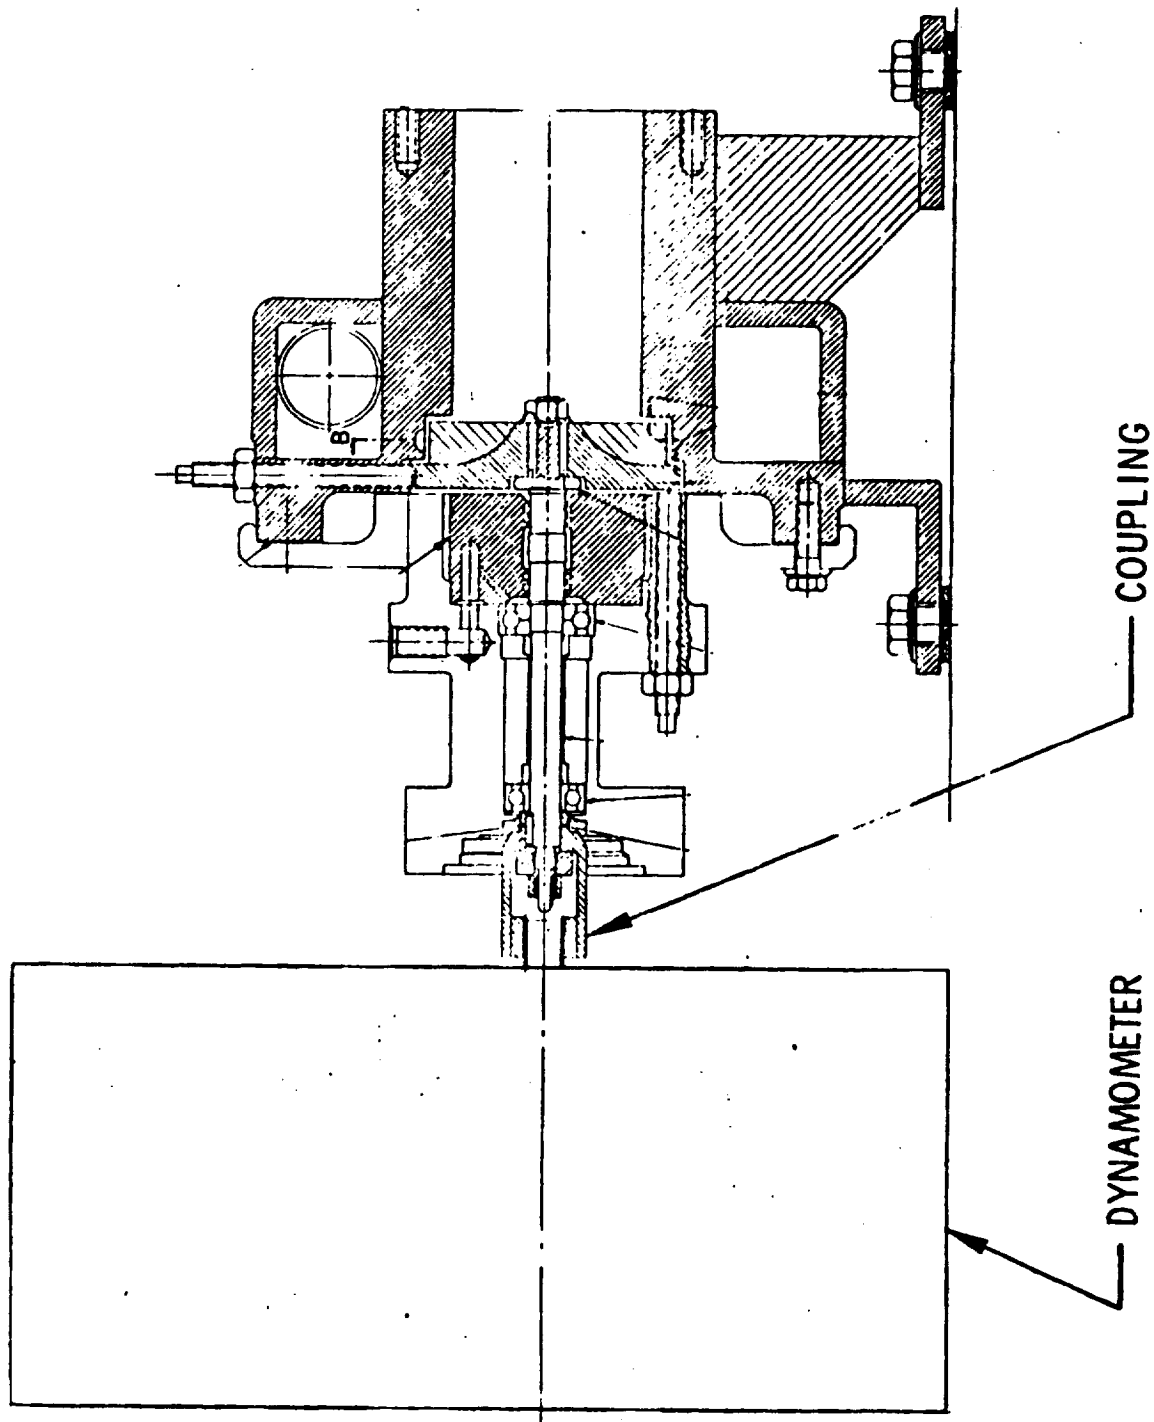
Figure 16 shows the mechanical configuration used for calibration. The volute, bearings, shaft, and turbine components of the standard pump assembly were used. A spline coupling, which connected the shaft to the dynamometer, was mounted in place of the inducer and impeller. The shaft seal package was replaced by a labyrinth seal to minimize the torque absorbed between the turbine and the dynamometer. With this configuration, the only power dissipation between the turbine and the dynamometer was due to the bearings, which is considered negligible. Bearing cooling was accomplished by introducing a small quantity of Freon 21 between the labyrinth seal and the rear bearing and allowing it to flow through both bearings, after which it evaporated into the atmosphere.

Figure 16. Mark 36 Gas Turbine Calibration Fixture

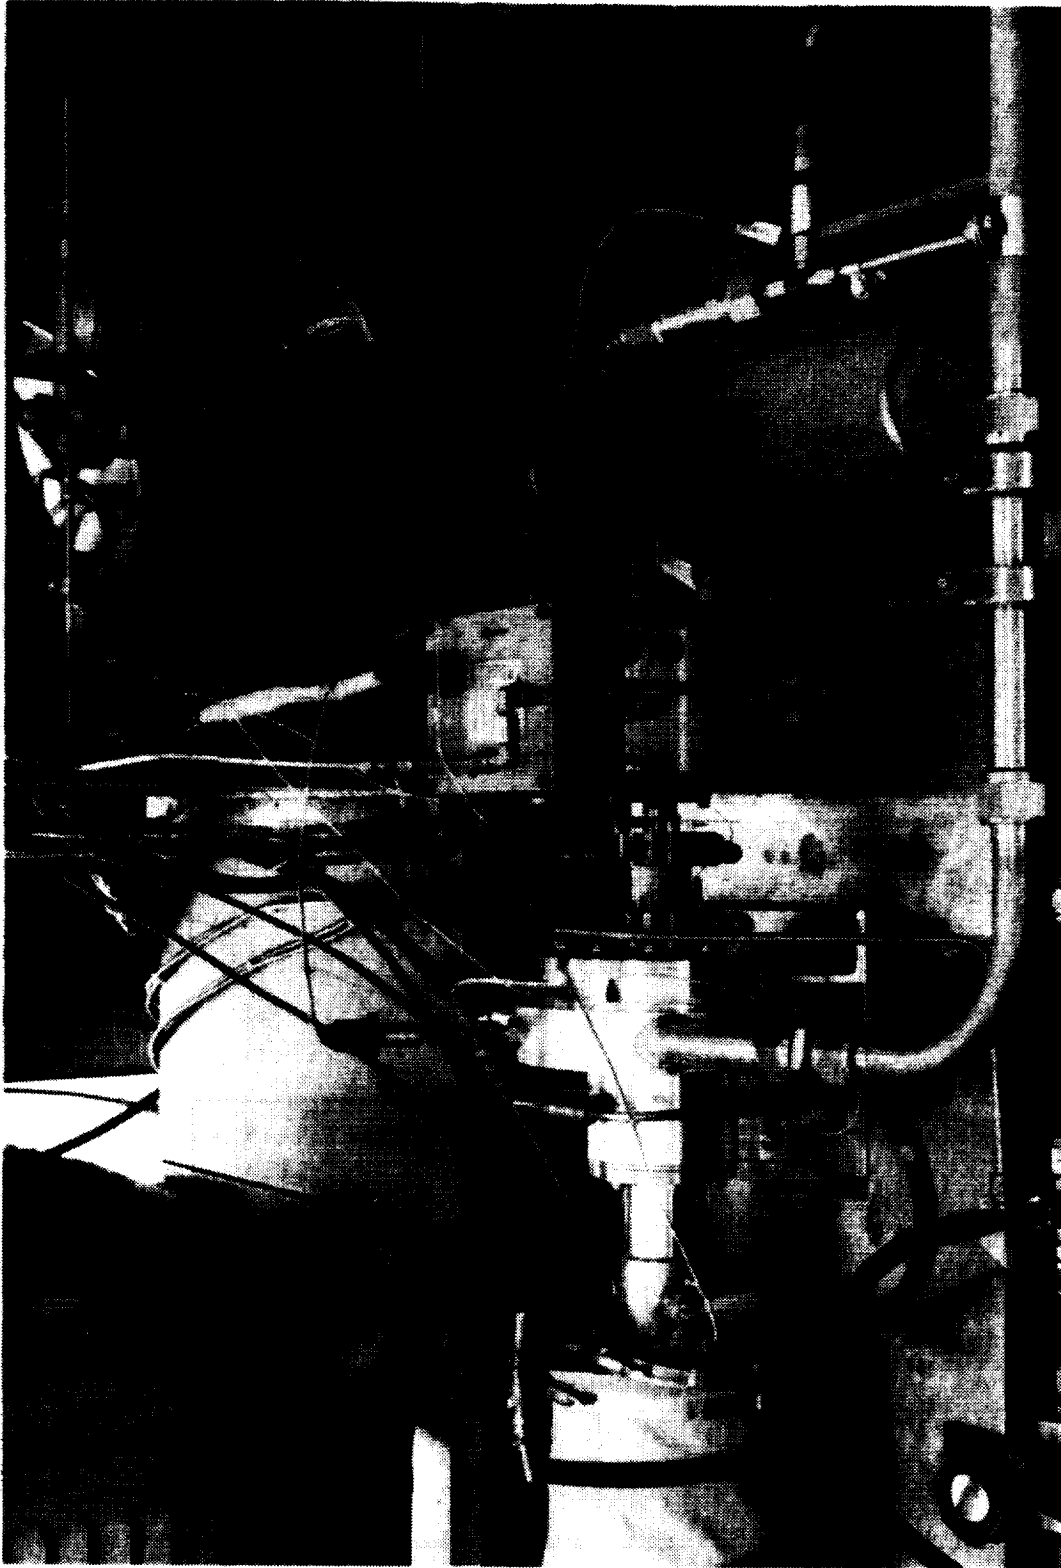
6AL46-5/6/70-C1

Figure 17. Mark 36 Turbine Calibration Installation

The turbine calibration revealed that the pump shaft first critical speed was at approximately 28,800 rpm, compared to the predicted value of 25,650 rpm. Turbine disk radial motion was monitored with a Bently transducer. It was found that the shaft was experiencing subsynchronous whirl at speeds above 45,000 rpm. Radial motion amplitude of 0.006-inch (1.52×10^{-4} m) peak to peak were observed above that speed range typically, compared to a maximum of 0.011 inch (2.8×10^{-4} m) noted when passing through the first critical speed. One test was terminated when the turbine radial motion reached approximately 0.015-inch (3.8×10^{-4} m) peak to peak at 68,000 rpm and appeared to be increasing. Subsynchronous whirl can originate from fluid film effects or rotor internal friction effects. Since the rotor used during turbine calibration was of interim configuration, which differed from the operational rotor (inducer and impeller were replaced by coupling), no effort was expended to pinpoint the source of the whirl. All test objectives were achieved in that the performance of the turbine was defined over the desired range.

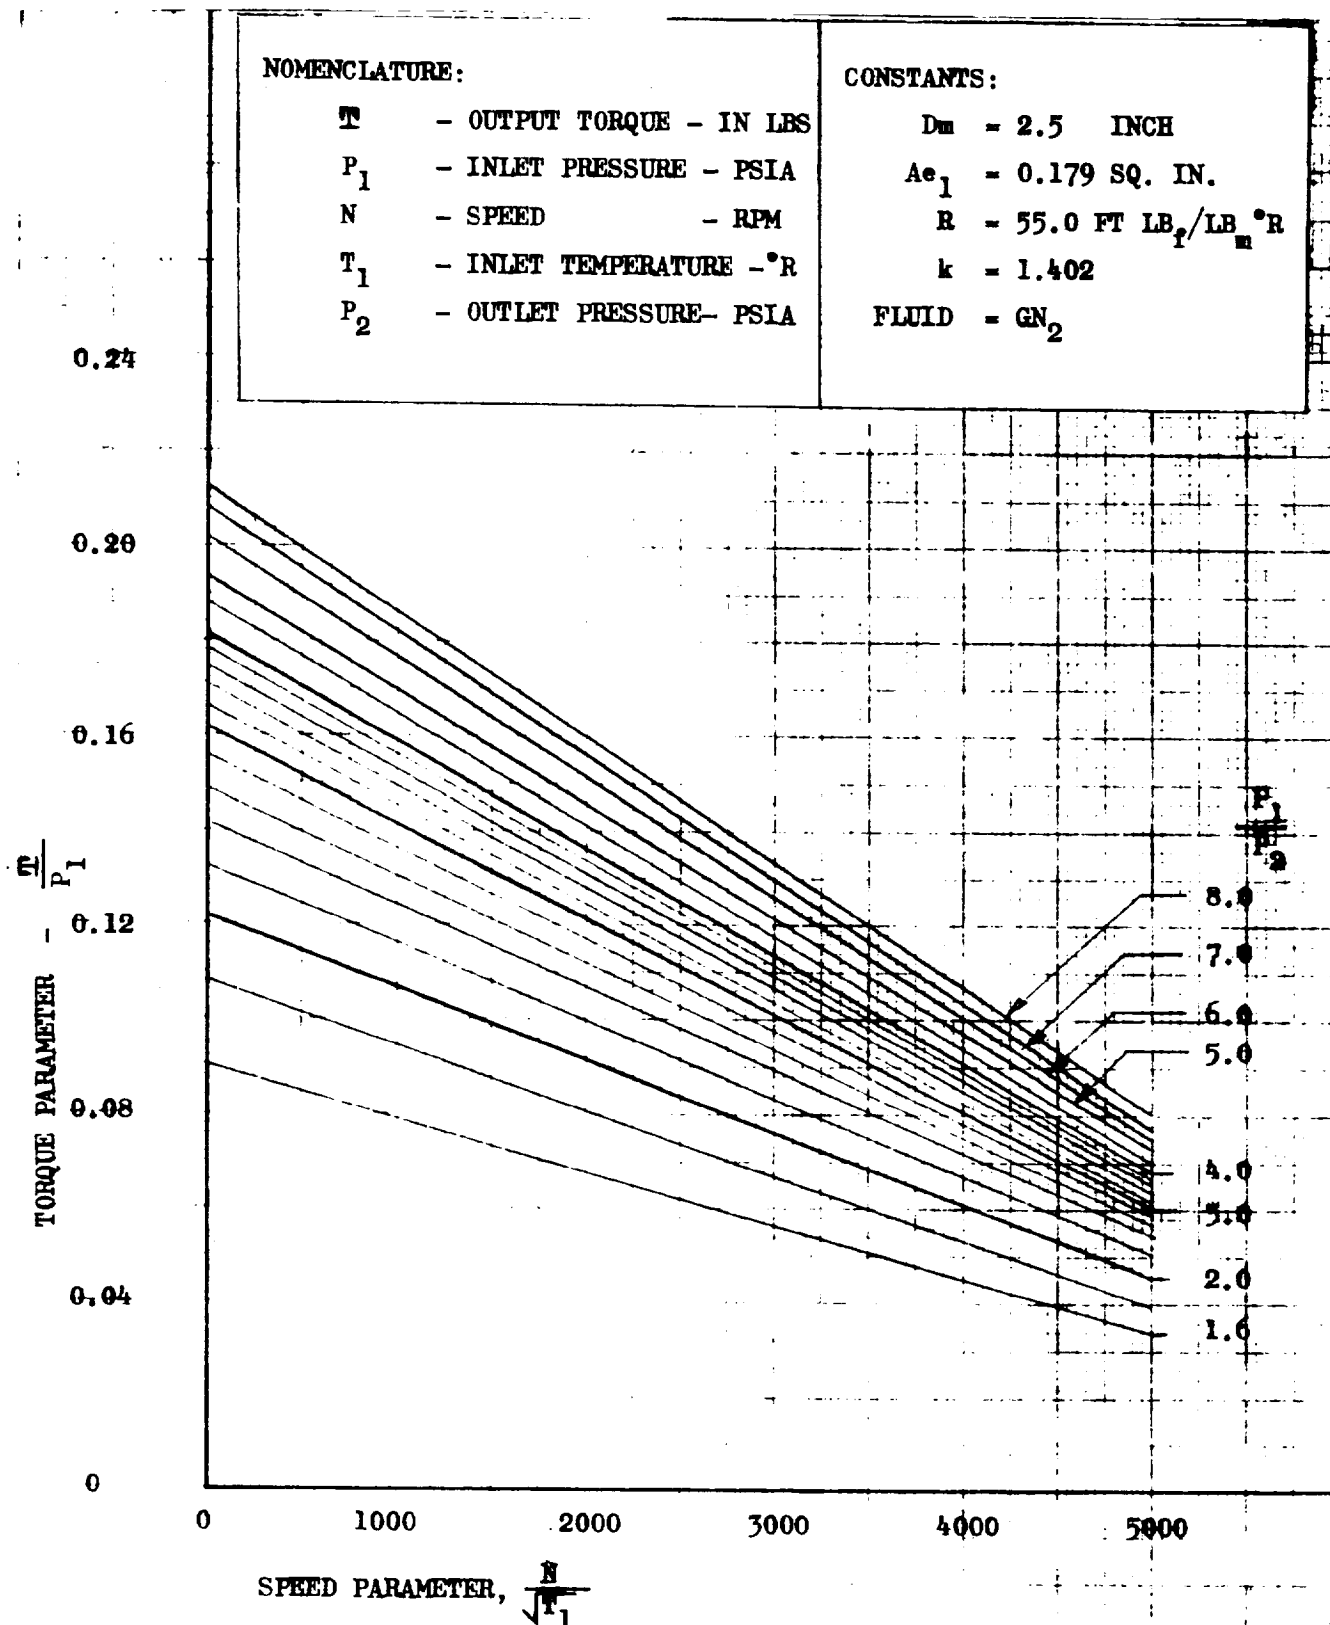
Figure 18. MK 36 Turbine Performance Map (Based on Analysis of Turbine Calibration Tests With Vortec - A-20 Dynamometer)

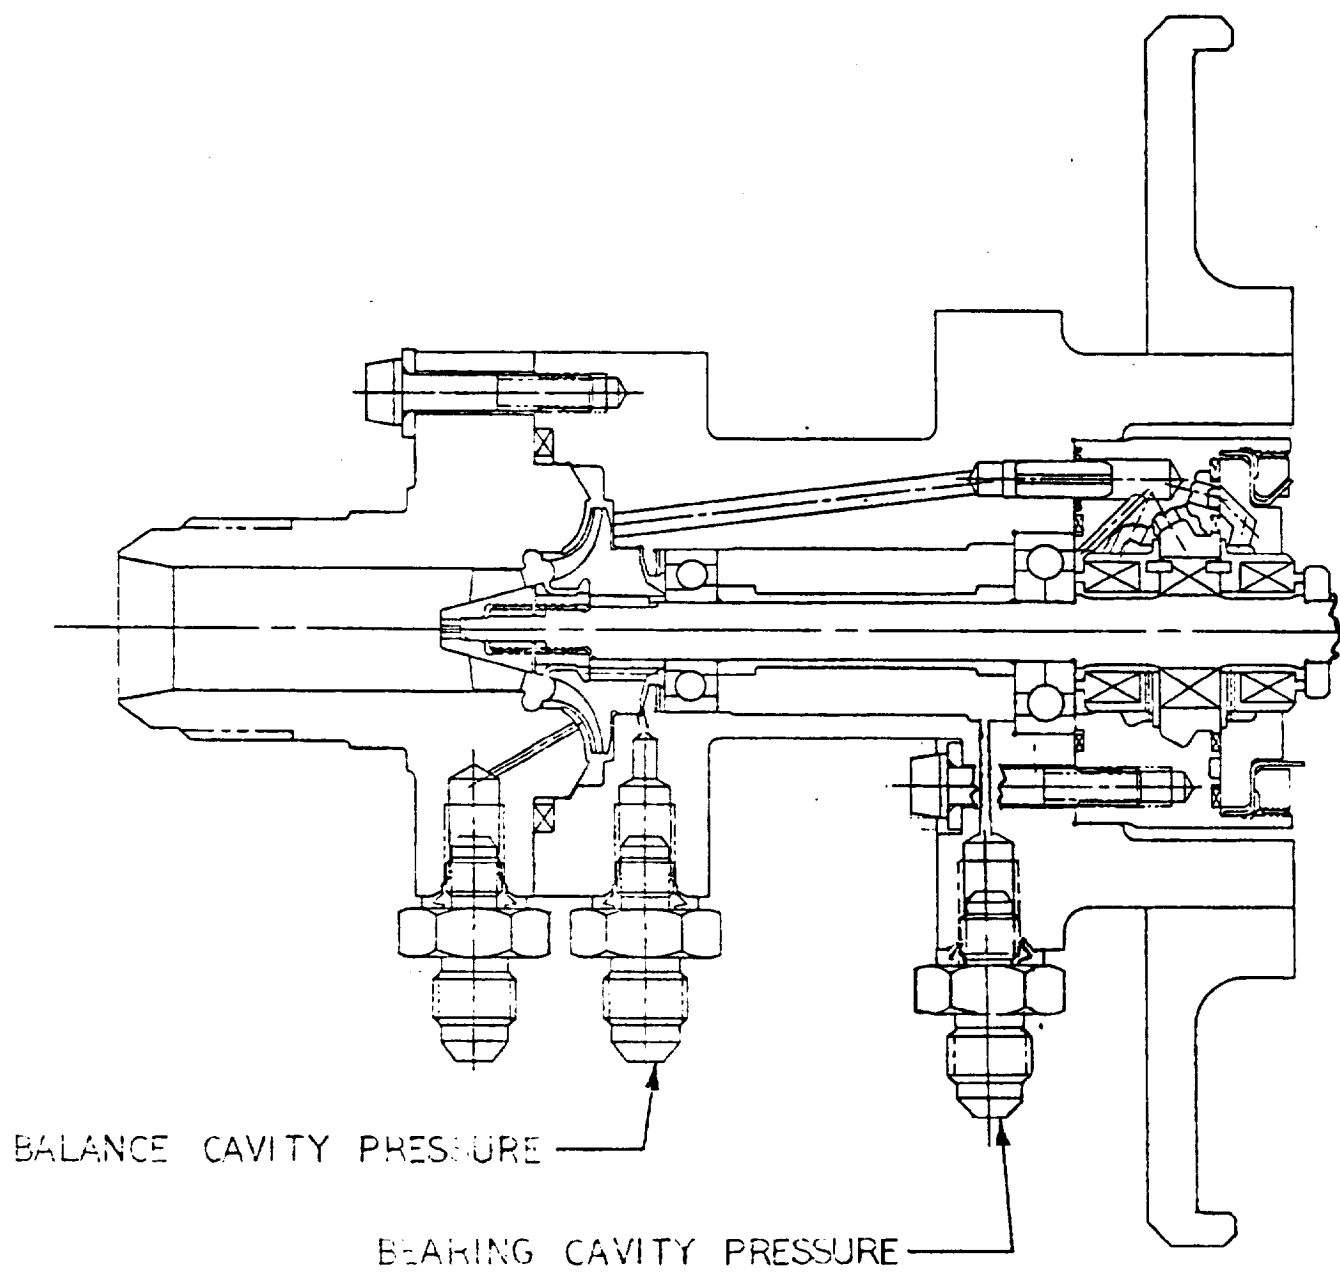
Figure 19. Pressure Tap Locations

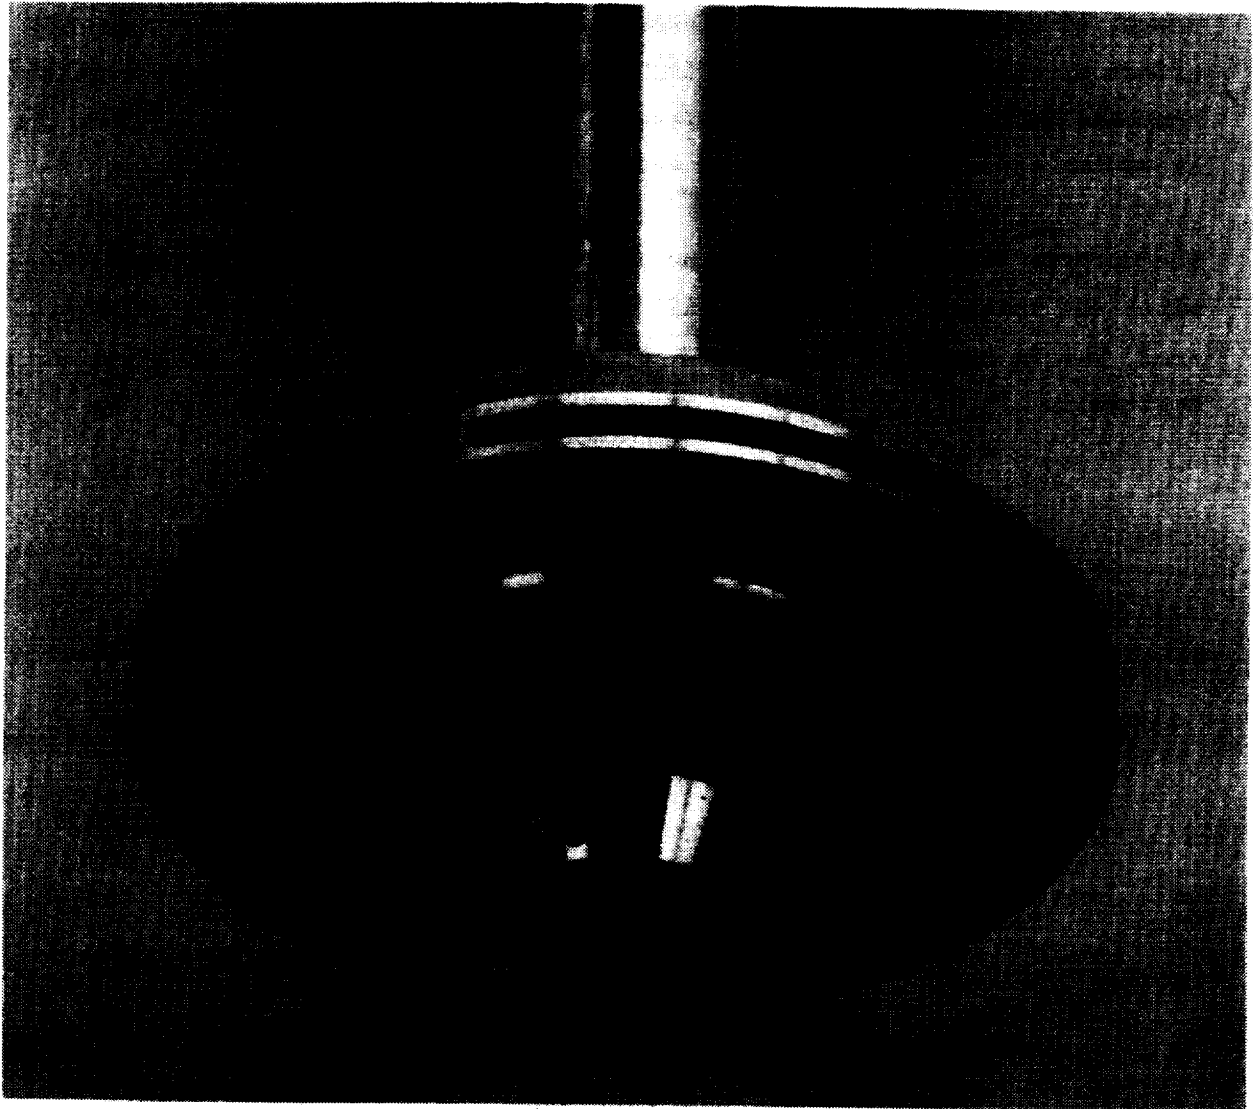
1XY55-6/23/70-C1A

Figure 20. Mark 36 Centrifugal Pump Impeller Rear
Wear Ring Hub After Test No. 11

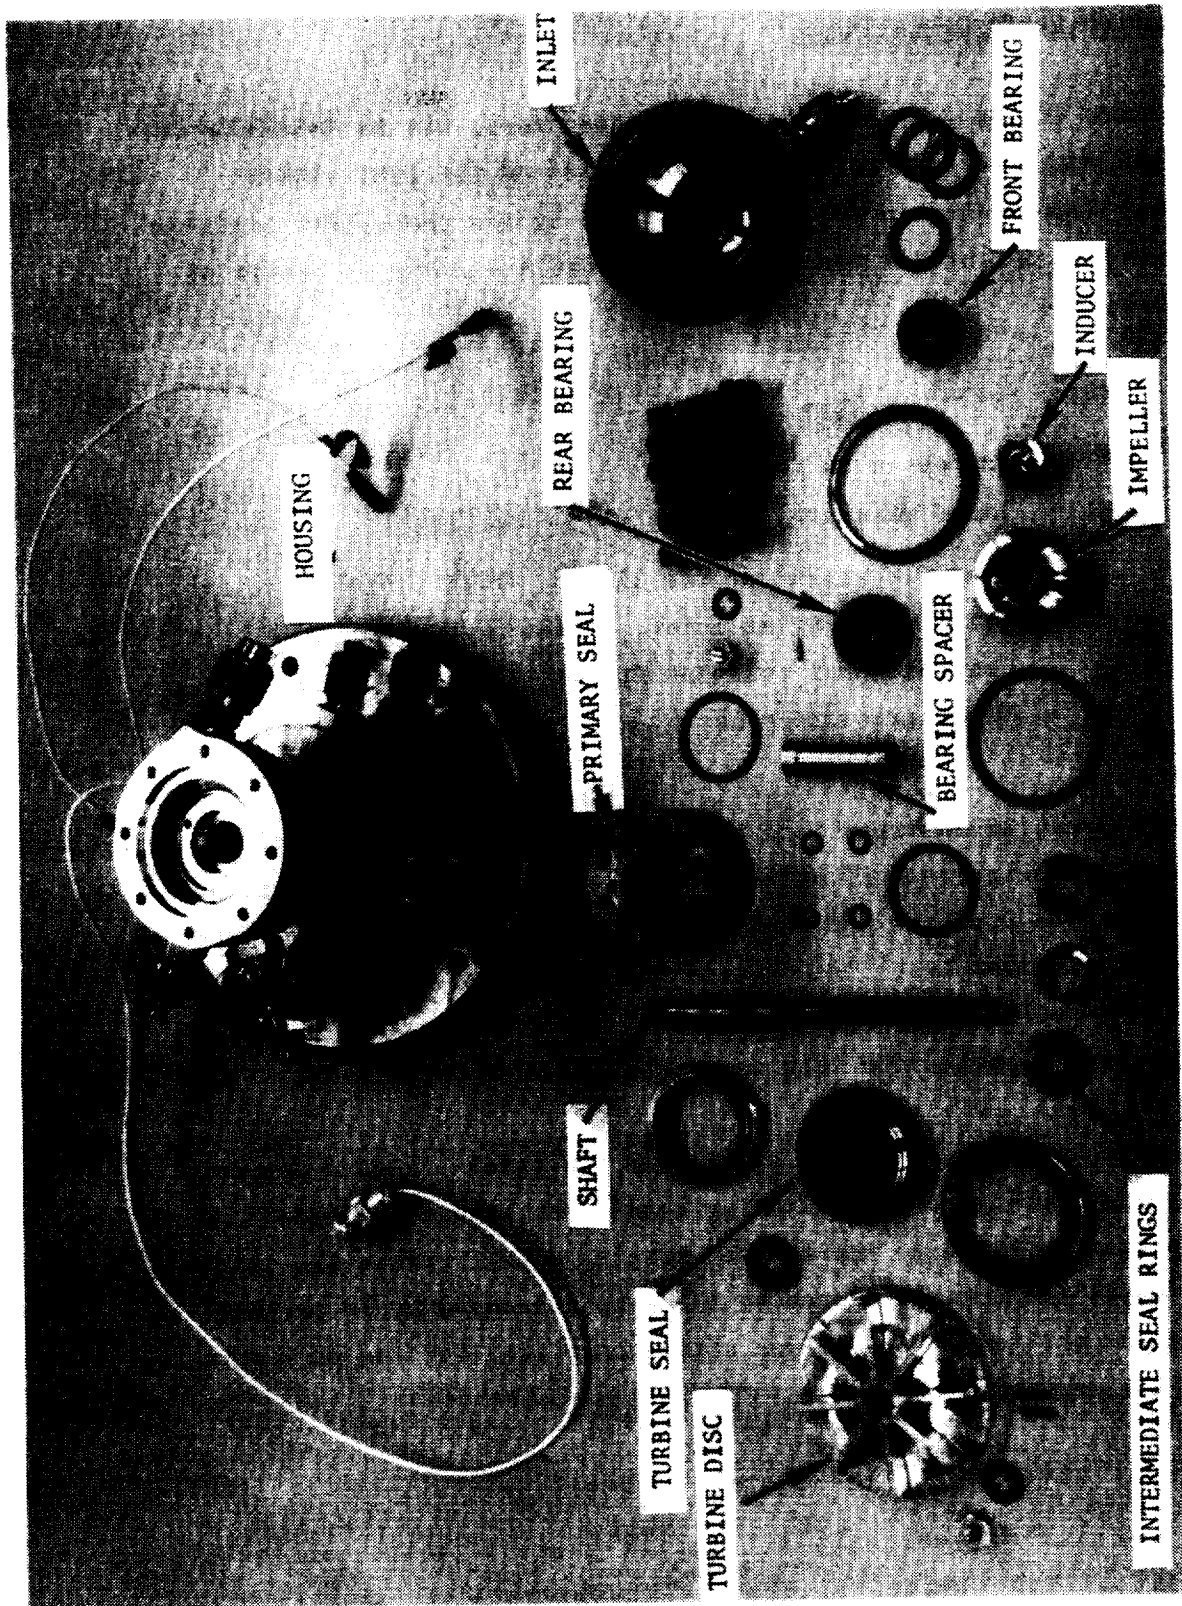
1XY55-6/23/70-C1F

The turbine seal had incurred a bellows failure identical to that experienced after the initial test series. All other hardware, including the primary seal, was in excellent condition. Figure 21 shows the detail parts after test #011.

Figure 21. Mark 36 Centrifugal Pump Disassembled After Test No. 11

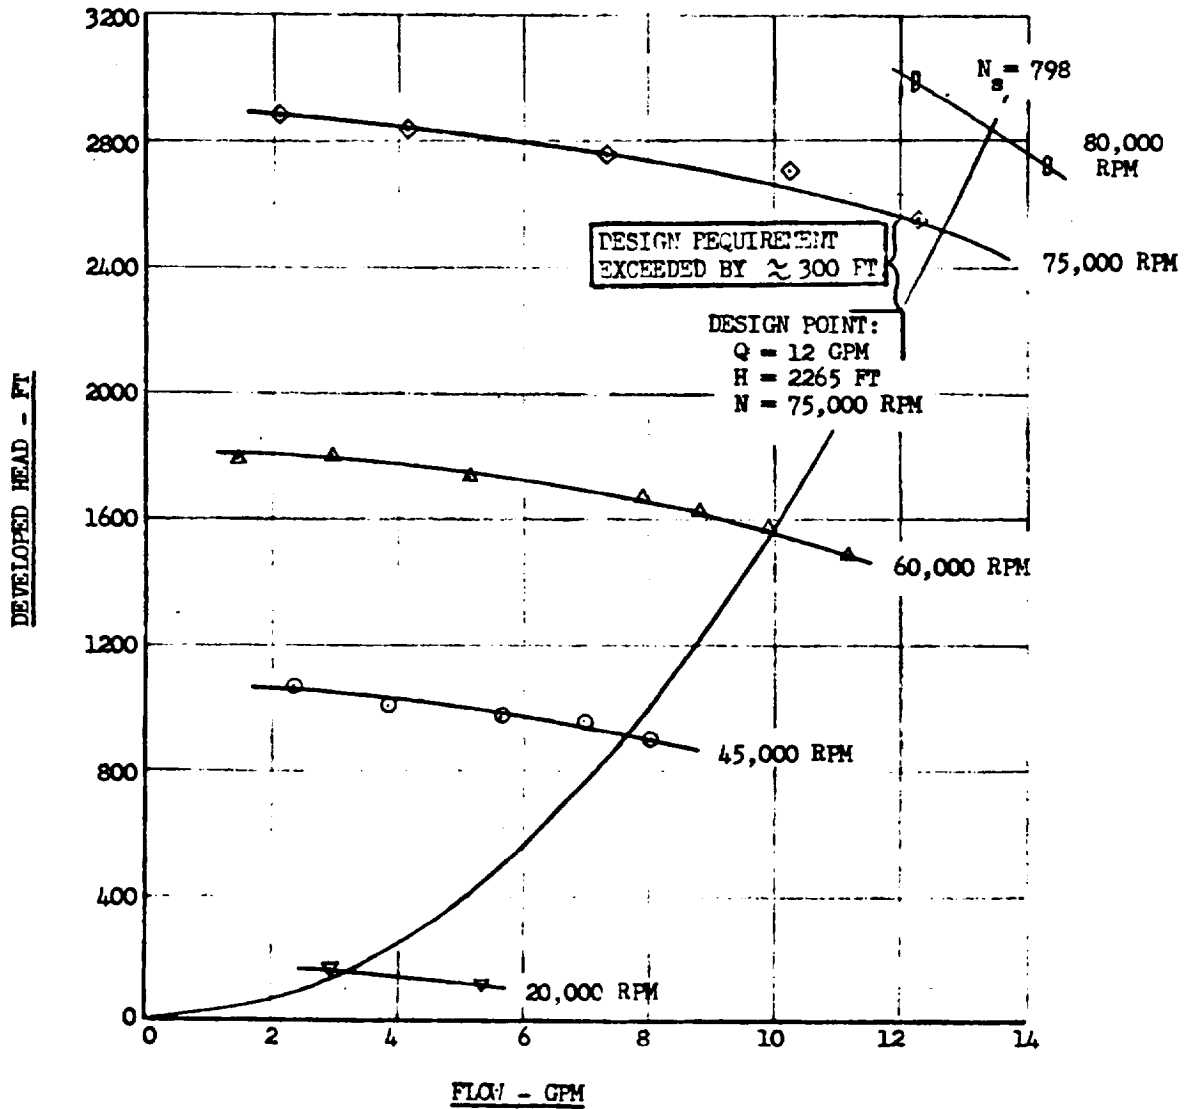
<u>SYM.</u>	<u>TEST NO.</u>	<u>AVERAGE TEST SPEED</u>
▽	02	20,000 RPM
○	07	47,000 RPM
△	08	62,000 RPM
◇	09	74,000 RPM
◻	10	80,000 RPM

Figure 22. Mark 36 (12 gpm) Centrifugal Pump in Freon 12

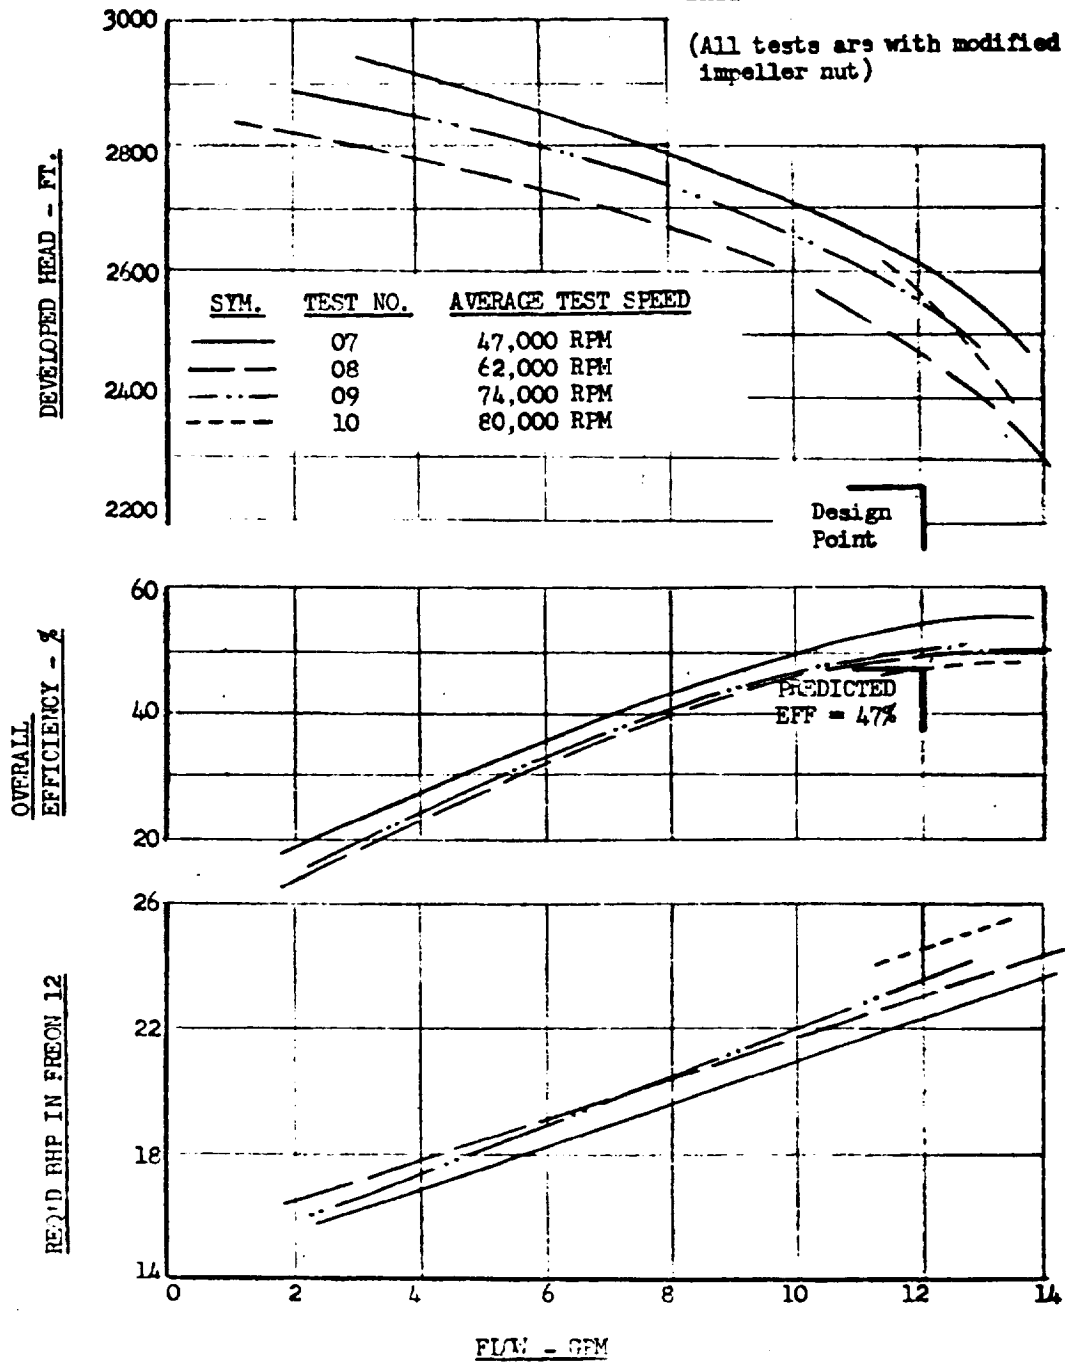
ALL DATA SCALED TO 75,000 RPM

Rear W.R. Dia.Cl. = 0.0034"
Front W.R. Dia.Cl. = 0.011"
Inducer Dia.Cl. = 0.0182"

Figure 23. Mark 36 (12 gpm) Centrifugal Pump in Freon 12

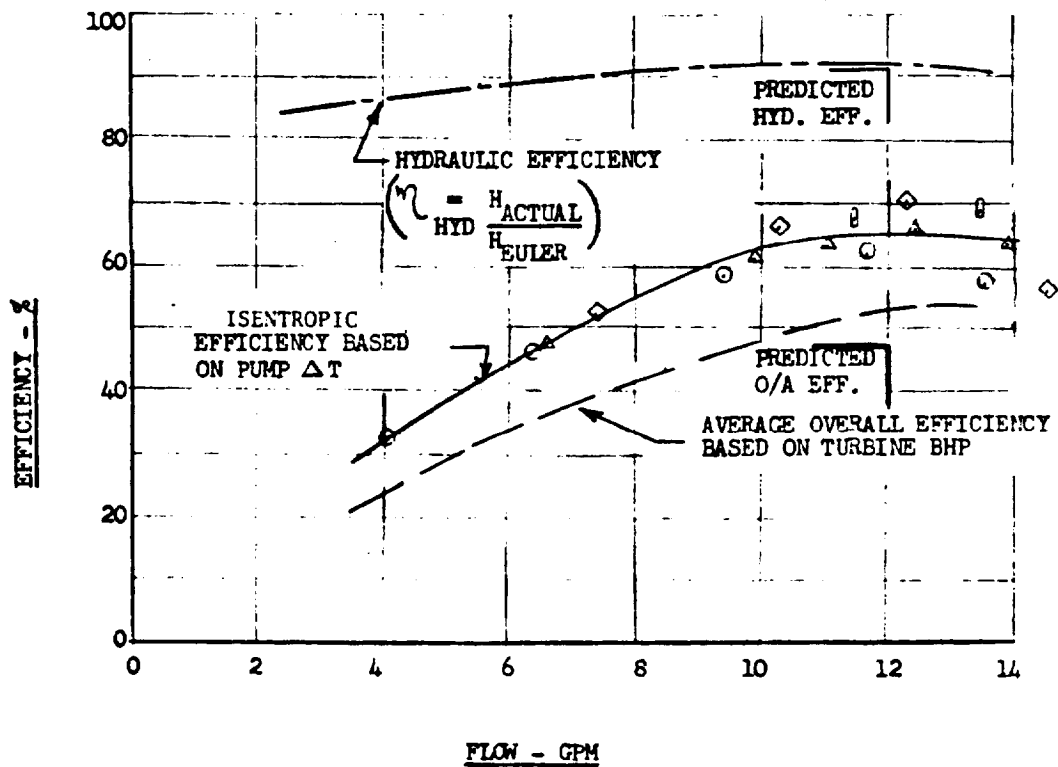
<u>SYM</u>	<u>TEST NO.</u>	<u>AVERAGE SPEED</u>
○	07	47,000 RPM
△	08	62,000 RPM
◇	09	74,000 RPM
0	10	80,000 RPM

Figure 24. Mark 36 (12 gpm) Centrifugal Pump in Freon 12; Comparison of Hydraulic and Overall Efficiencies

seal test data, this power is calculated at 4.8 HP (3580 watts) with the primary seal pressurized to 200 psig ($1.38 \times 10^6 \text{ N/m}^2$). With the seal package absorbing 4.8 HP, the difference between the isentropic efficiency and the overall efficiency should be 13 percentage-points. The actual data correlates with that very well, in that the difference between the average curves is exactly 13 percentage points at nominal Q/N.

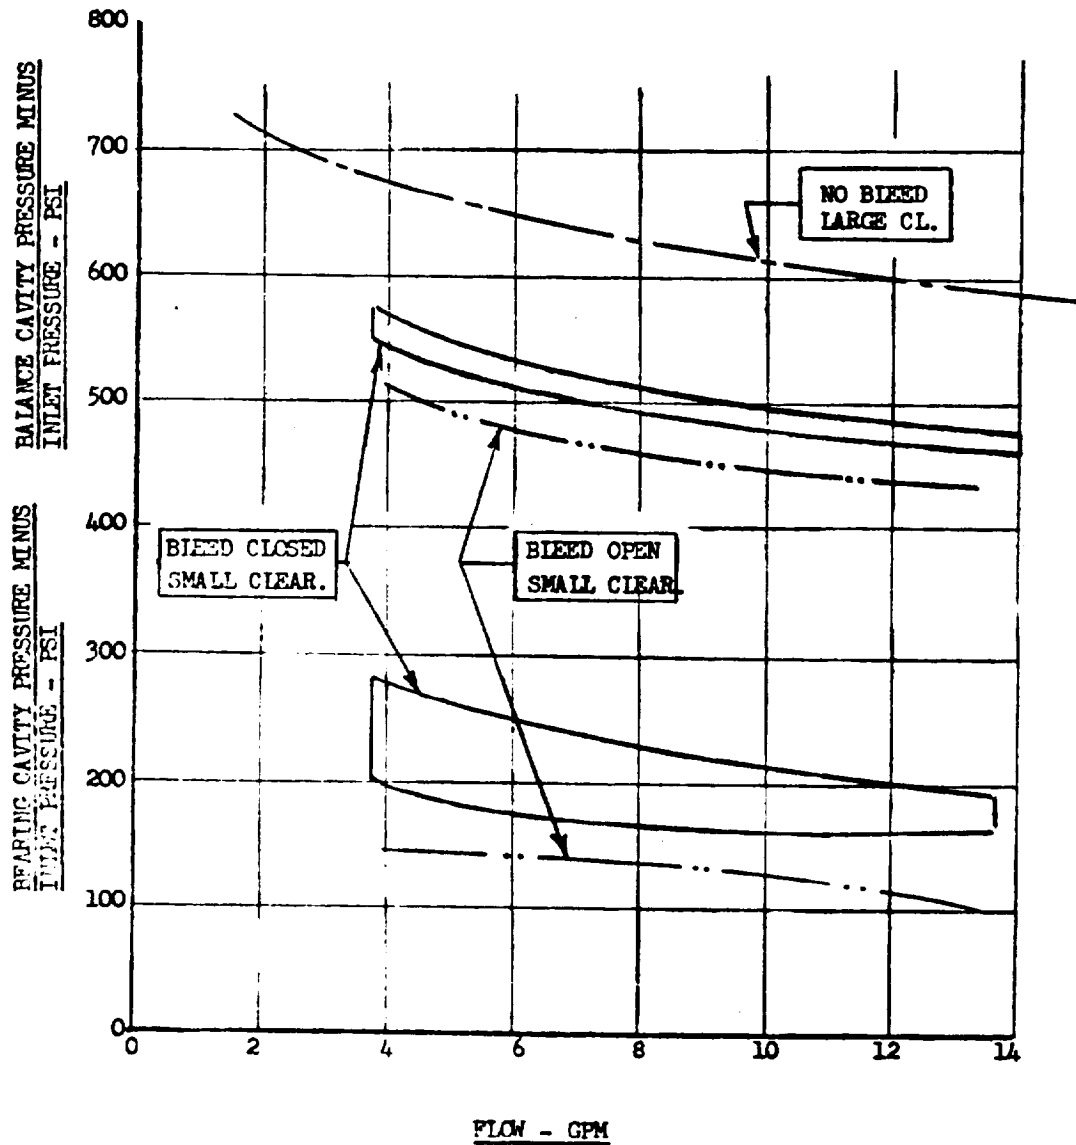
ALL DATA SCALED TO 75,000 RPM

Figure 25. Mark 36 (12 gpm) Centrifugal Pump in Freon 12; Effect of Rear Wear Clearance and Bearing Cavity Bleed Flow on Balance Cavity and Bearing Cavity Pressures

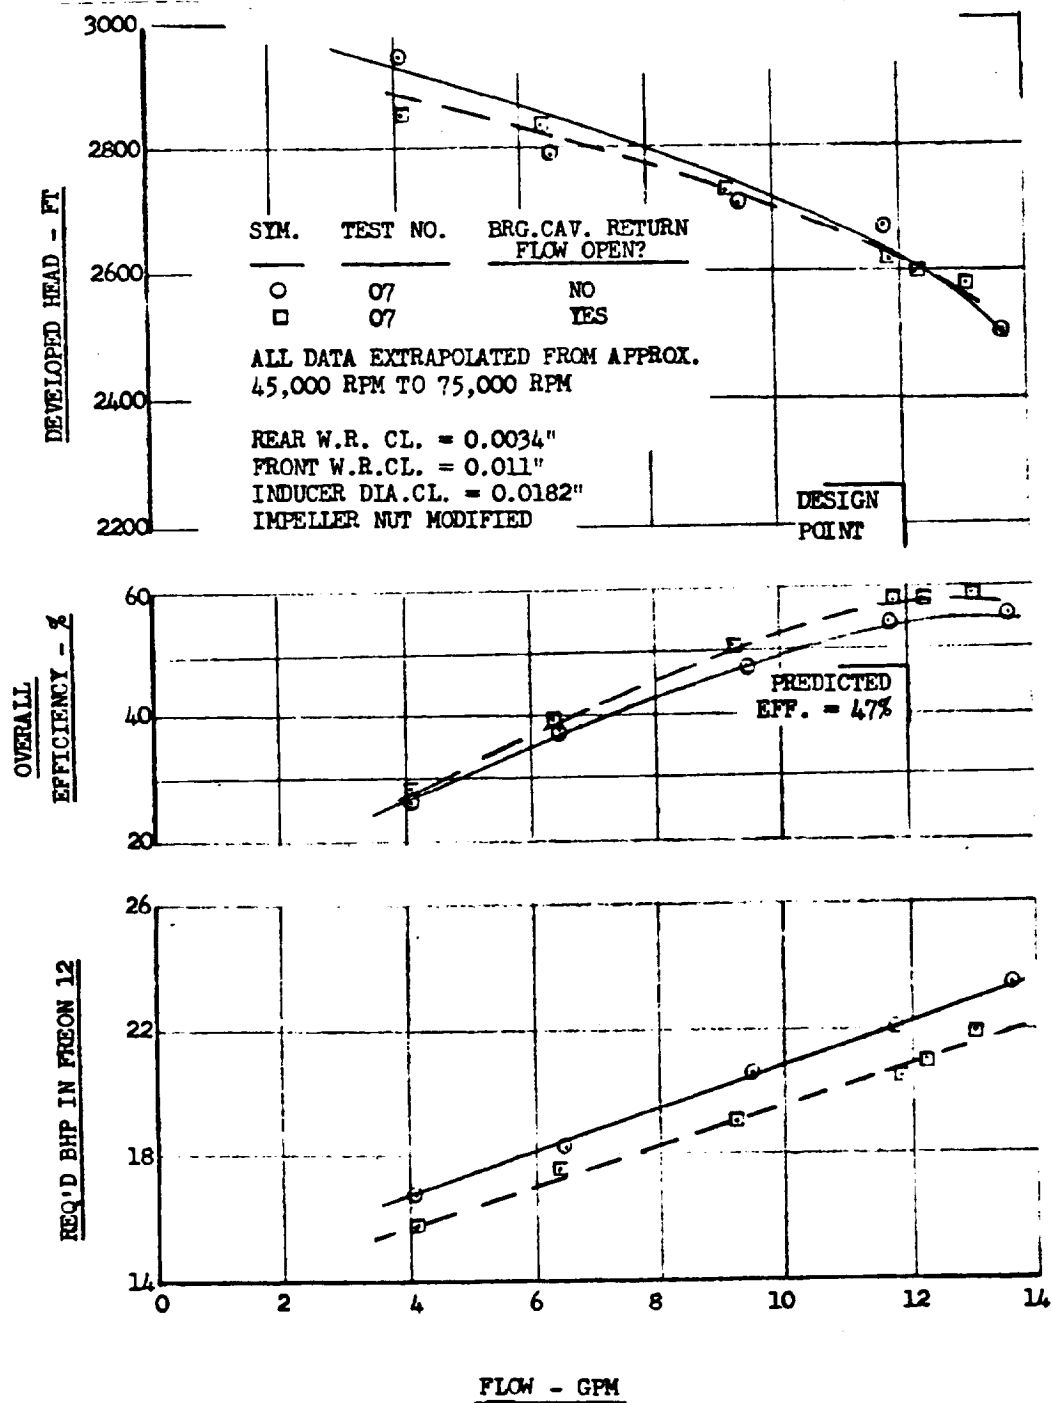
Figure 26. Mark 36 (12 gpm) Centrifugal Pump in Freon 12; Performance Comparison With and Without Bearing Cavity Return Flow
